# INSTALLATION RESTORATION PROGRAM

## PHASE I - RECORDS SEARCH AAC-NORTHERN REGION

Galena AFS  
Campion AFS  
Cape Lisburne AFS  
Fort Yukon AFS

Indian Mountain AFS  
Kotzebue AFS  
Murphy Dome AFS  
Tin City AFS

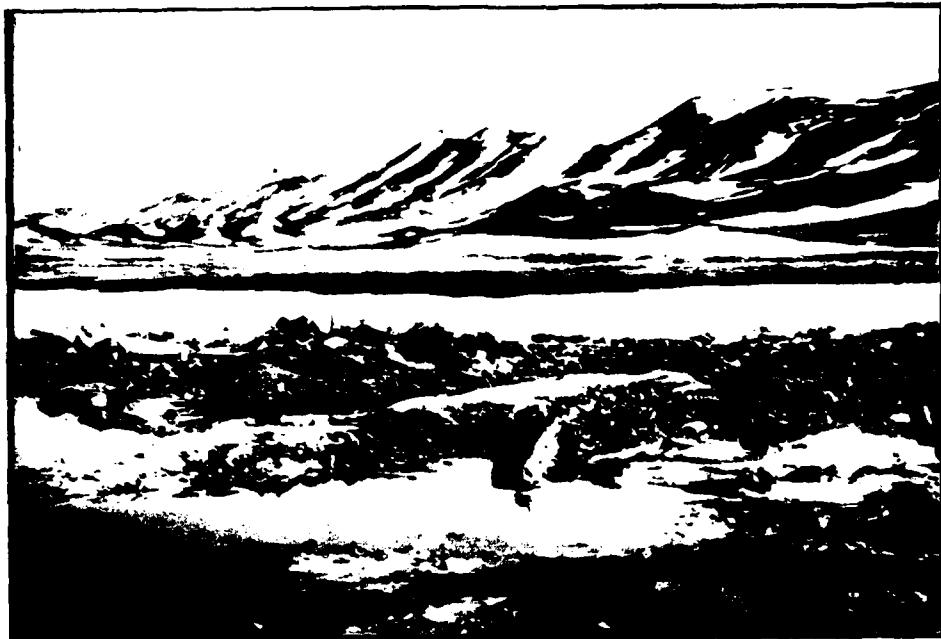
Landfill  
(FACING SOUTHEAST)

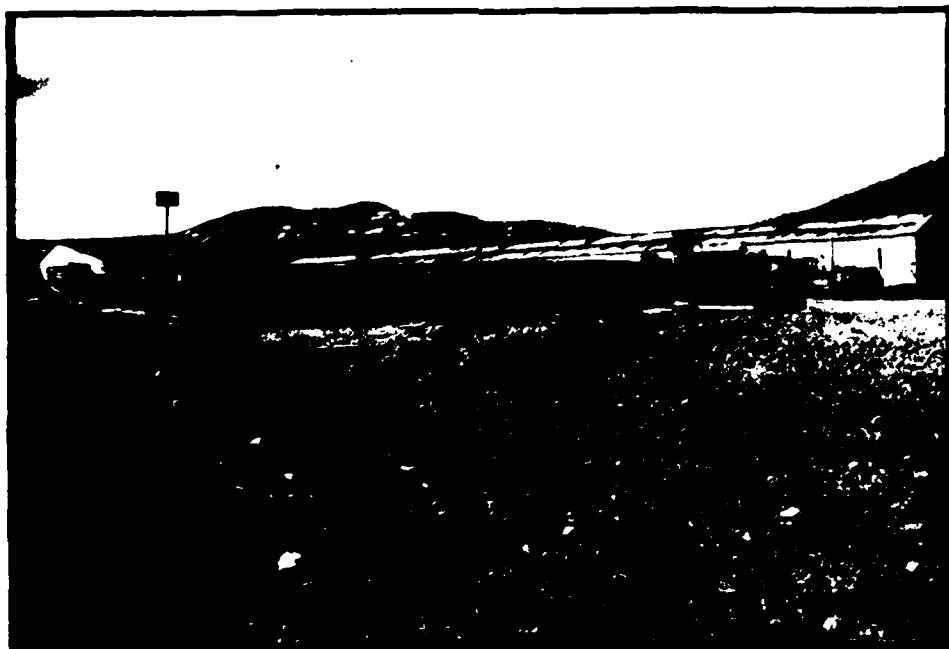
Waste Accumulation Area No.1  
(FACING NORTHWEST)

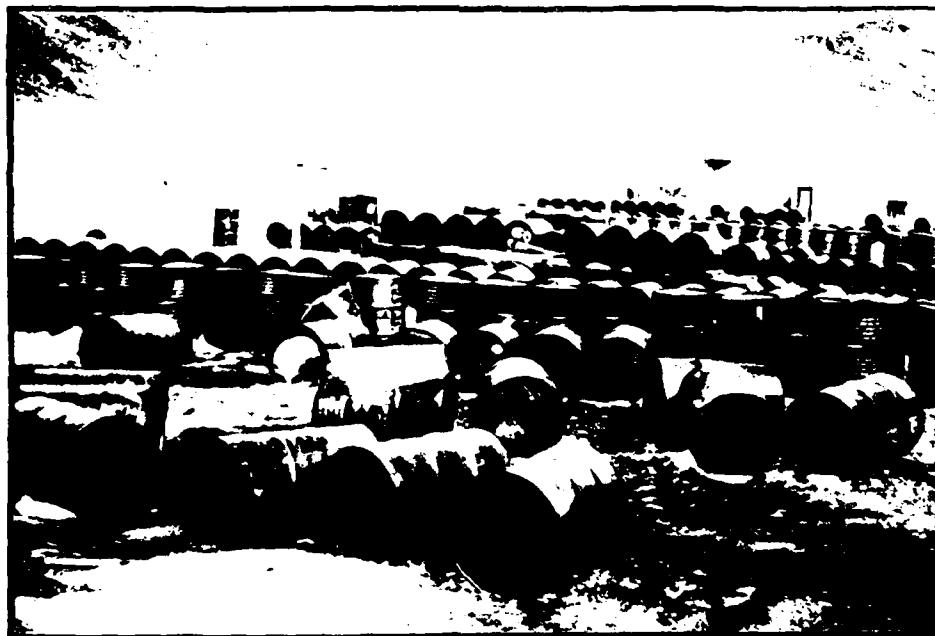
Waste Accumulation Area  
(FACING NORTHWEST)
